# The ATE T50 Brake Booster

## Fifty percent less pedal force

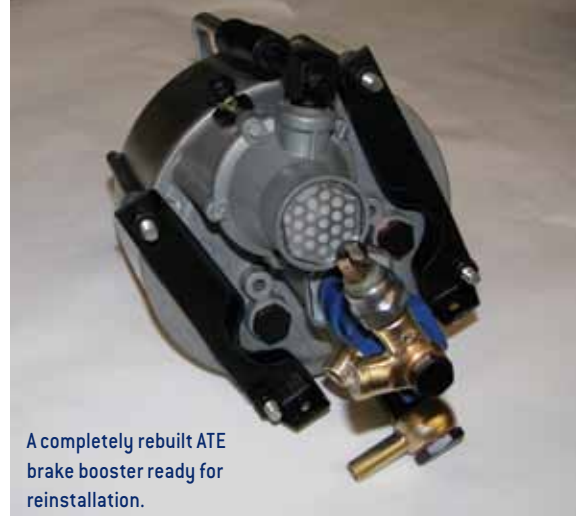
A completely rebuilt ATE brake booster ready for reinstallation.

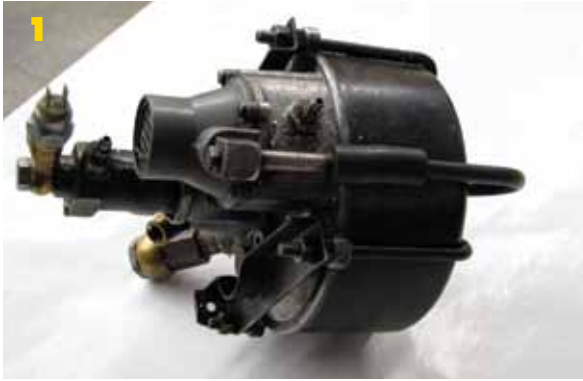
1. Typical brake booster upon arrival. 2. The disassembled booster. 3. Note the brake fluid that leaked into the vacuum chamber. This will result in lost brake fluid finding its way into the engine. Result? Low brake fluid in the reservoir and white

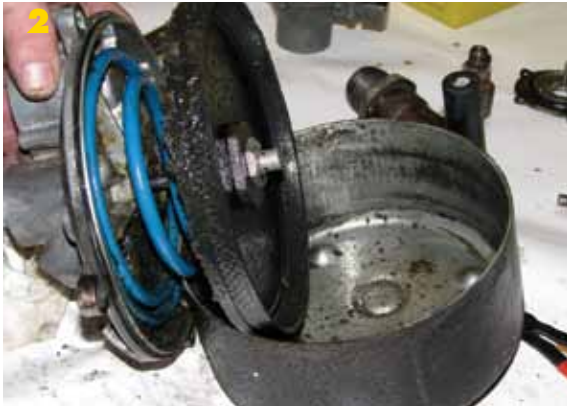
smoke burning from the exhaust. 4. Rear seal failure is common. 5. Todd Prevatte assembles the booster. 6. Booster now ready for assembly with M-B rebuild kit and parts cleaned and plated. 7. Booster on test stand before shipping.

Difficulties with brake-booster operation are normally associated with the failure of the internal shaft seal, which allows brake fluid to leak into the vacuum cylinder. If the leak is large, the loss of brake fluid will be apparent, and white smoke may be observed from the tailpipe. A slow leak, accompanied by occasional use of the car, can cause a gummy buildup in the vacuum chamber and will inhibit the free sweep of the piston. If this condition persists, the vacuum piston may freeze in place and the unit will no longer provide braking assistance. Mercedes-Benz recommends replacing the air-cleaner element every 10,000 miles.

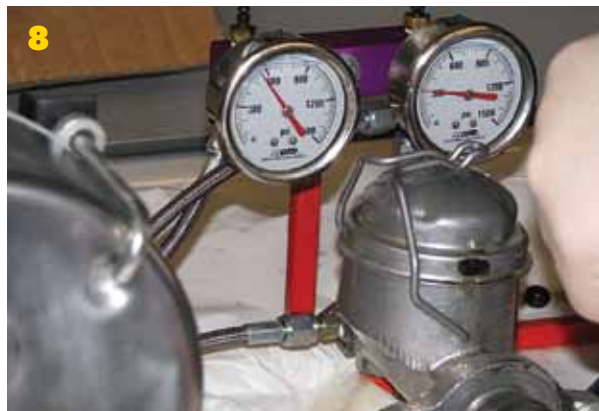
8. Readings indicate input pressure and output pressure. There are 300 pounds of input pressure and 600 pounds of output pressure, indicating what the booster is producing. Generally we look for output pressure to be double that of the input pressure.
